Bridge Inspections

Municipalities Could be Encouraged to
Take More Action with Improved
Communication of Deficiencies by the
Agency of Transportation

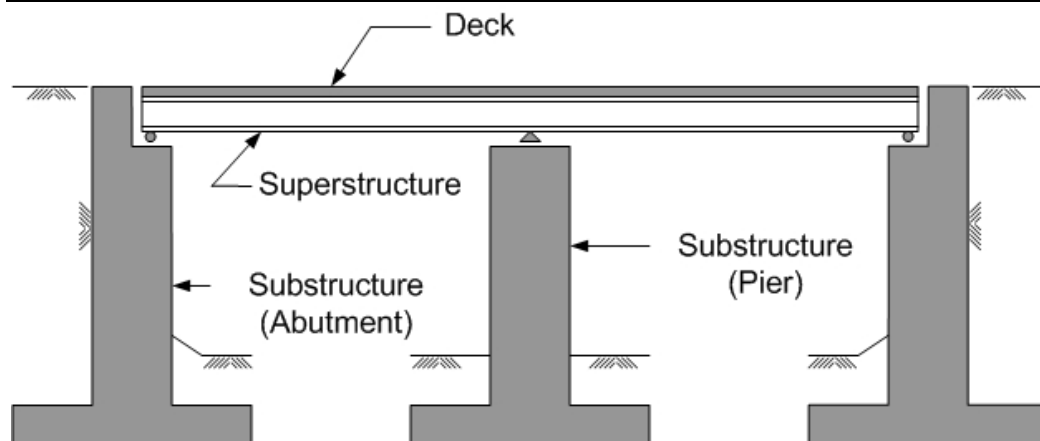
Figure 3: Major Bridge Components

As part of a bridge inspection, the VTTrans inspectors evaluate the condition of major bridge components. Figure 3 is an illustration of three of the major components: deck, superstructure, and substructure.⁸ Bridge inspectors also evaluate the condition of the waterway channel and its protection.⁹

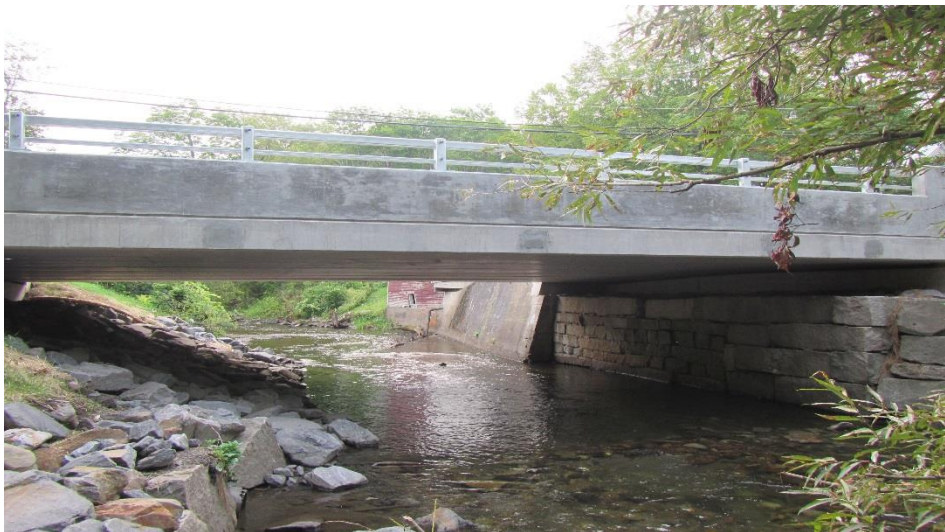
Photo from Latest VTrans Inspection

Structure in poor condition, including voids in the stone blocks of the abutments and piers.

VTrans replaced bridge as part of town highway bridge program.

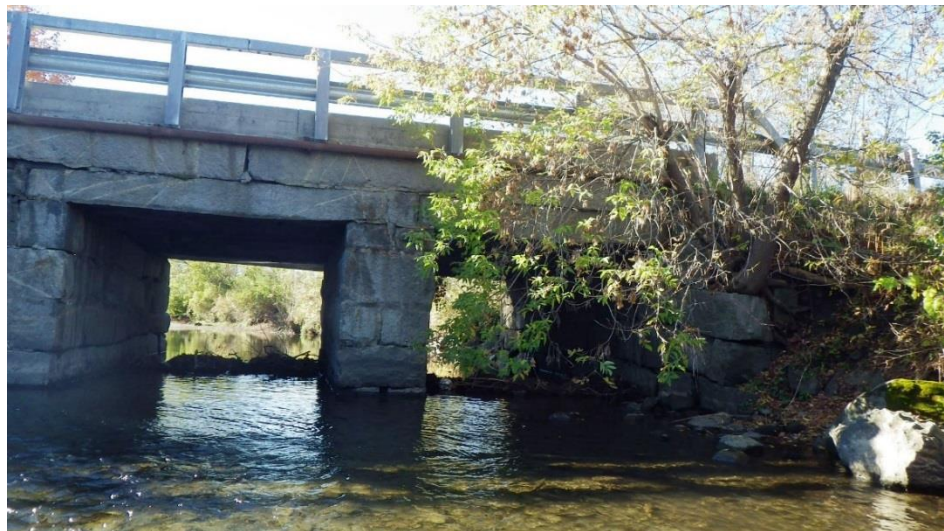
Photo and Finding from 2014 VTrans Inspection

Timber debris in spans 3 and 4 should be removed.

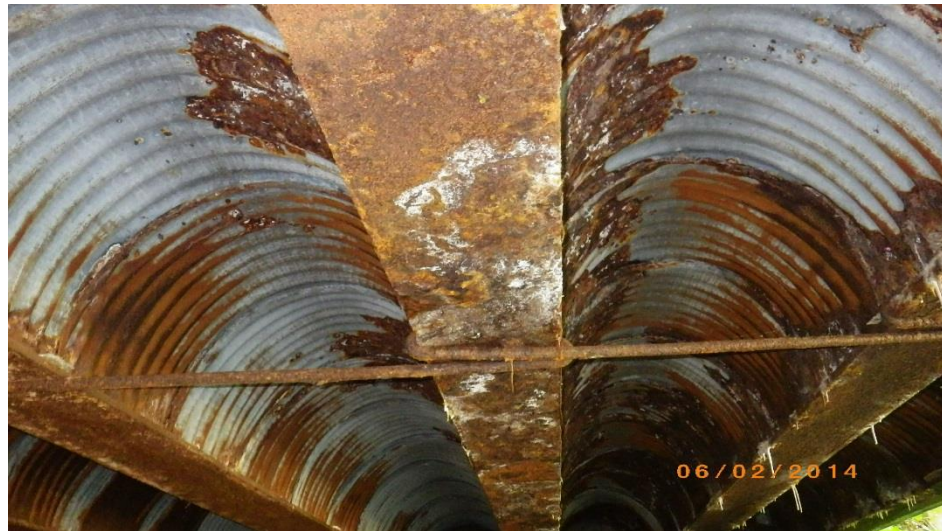
Photo from Latest VTrans Inspection

Deterioration of arches.

Bennington has not acted to address issue as of December 2017.

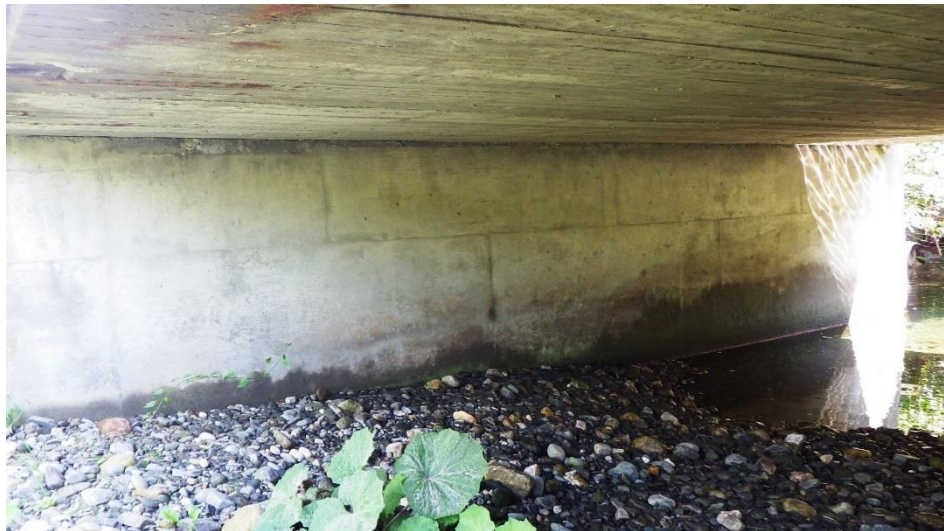
Photo and Finding from 2014 VTrans Inspection

Gravel bar should be removed.

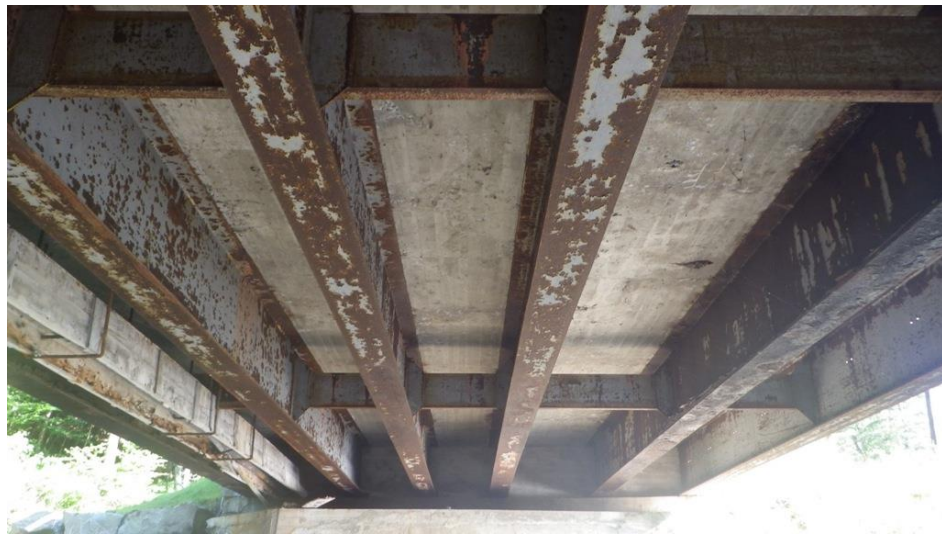
Photo and Finding from 2014 VTrans Inspection

Steel should be cleaned and painted.

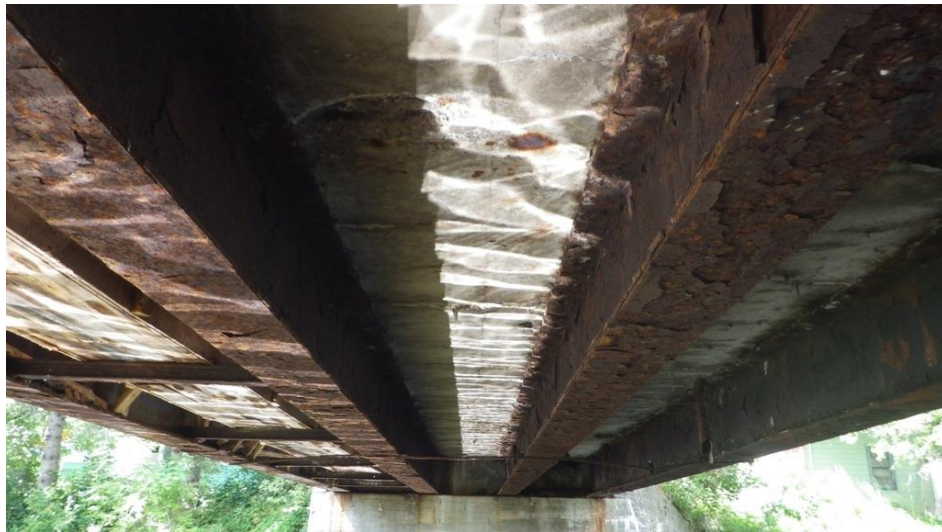
**Photo from 2016
VTrans Inspection**

Beams have very heavy rusting and minor crushing at abutment 2 end. Bridge needs replacement or extensive reconstruction.

VTrans plans to replace bridge in 2019 as part of town highway bridge program.

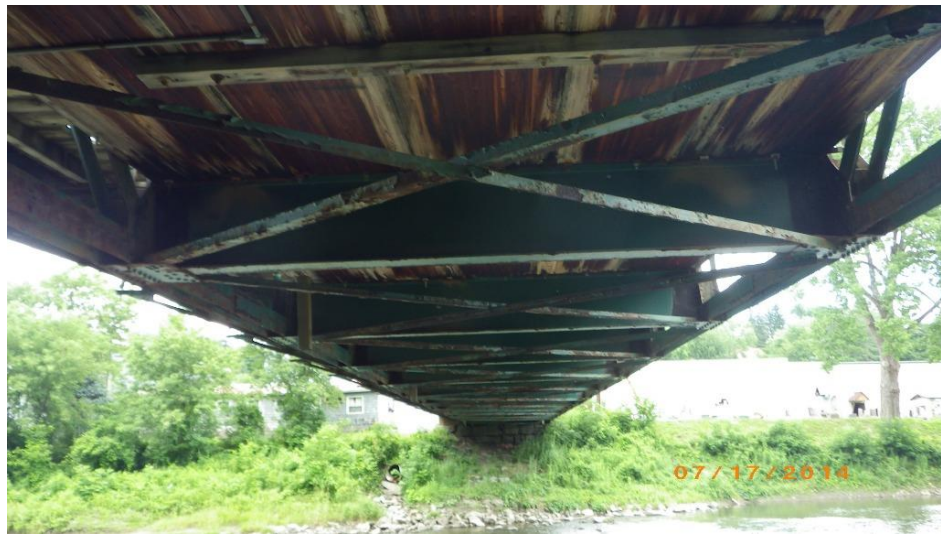
Photo and Finding from 2014 VTrans Inspection

Steel superstructure needs extensive cleaning and painting.

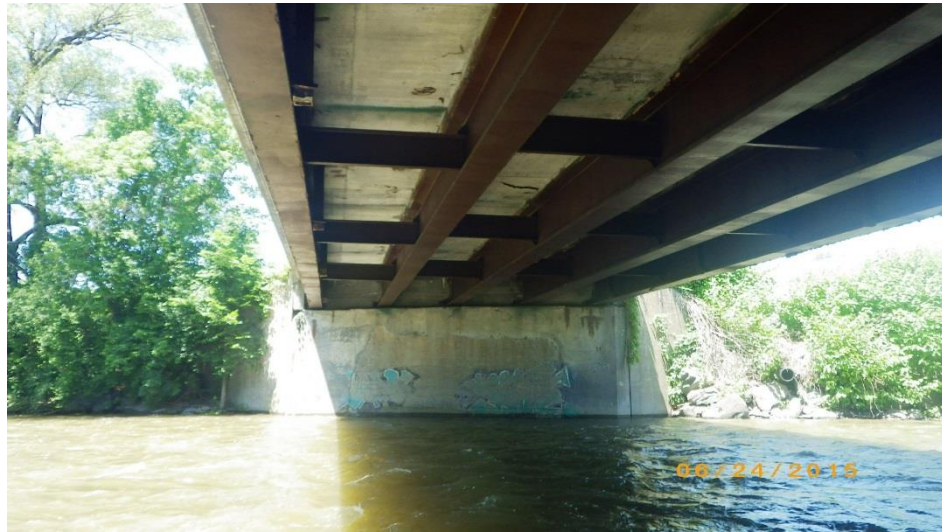
Photo from Latest VTrans Inspection

Abutments need cleaning and patch repair work

Montpelier has not acted to address issue as of December 2017.

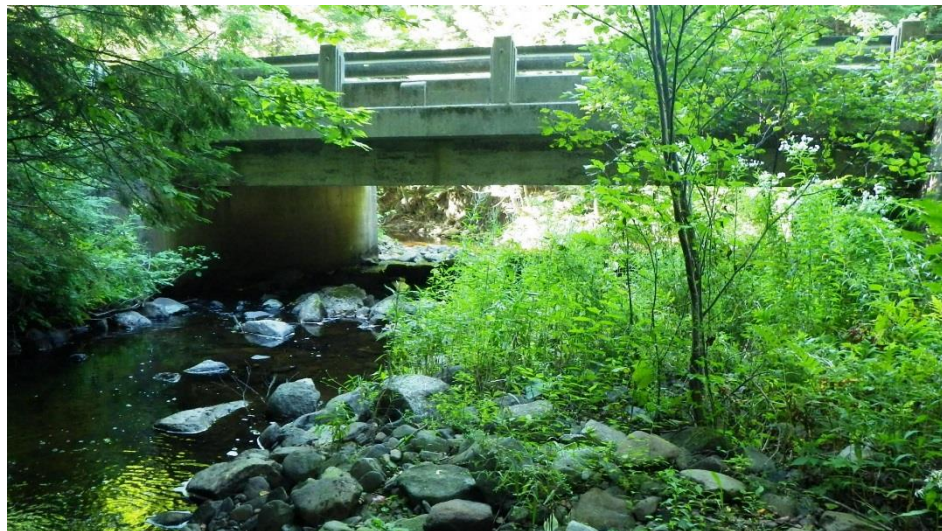
Photo and Finding from 2014 VTrans Inspection

Trees and brush on the upstream side should be removed from the channel.

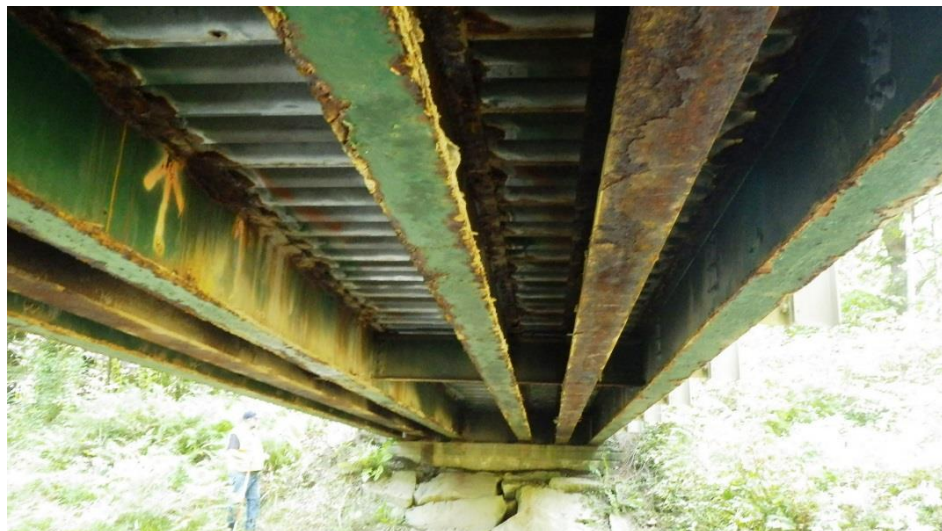
**Photo from Latest
VTrans Inspection**

Beams are in poor
condition.

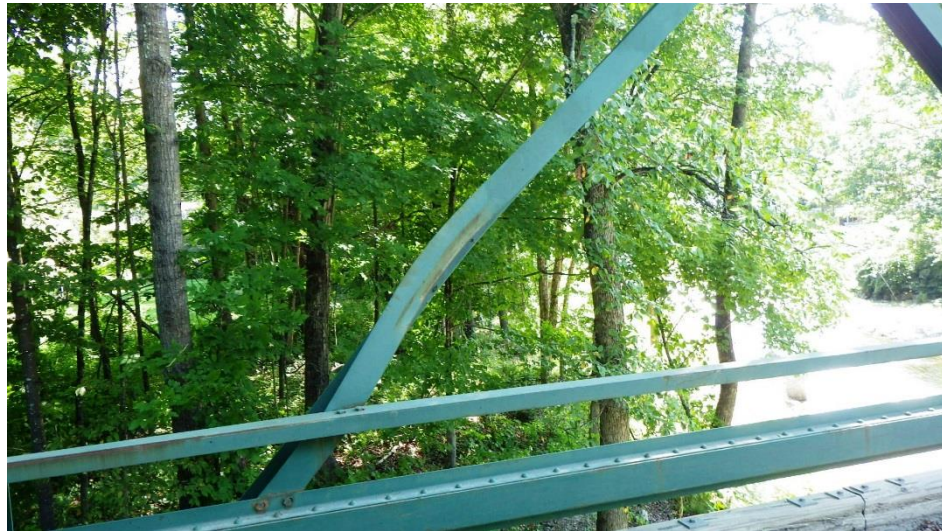
Photo from VTrans Inspection 4/6/2017

Diagonal bracing on the downstream side should be replaced.

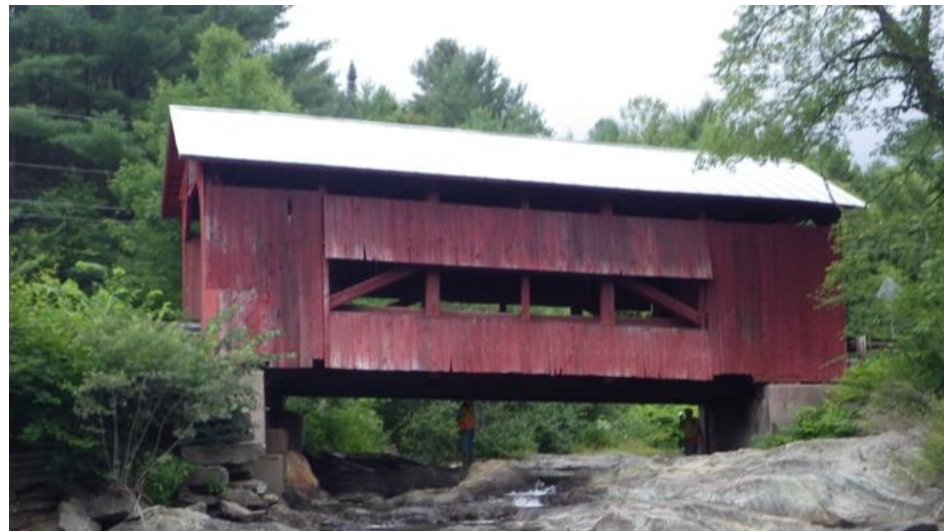
Photo and Finding from 2014 VTrans Inspection

Covered bridge portion needs reconstruction.

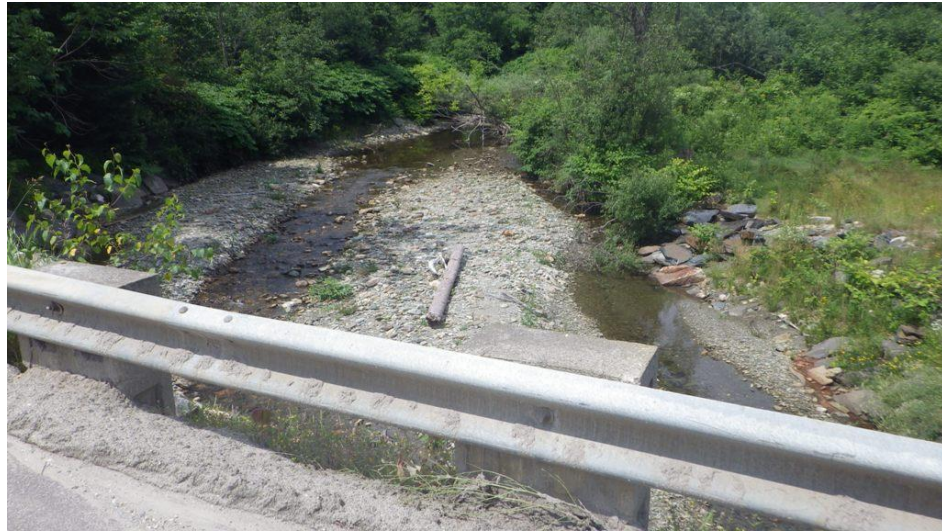
Photo and Finding from 2014 VTrans Inspection

Channel needs to be realigned.

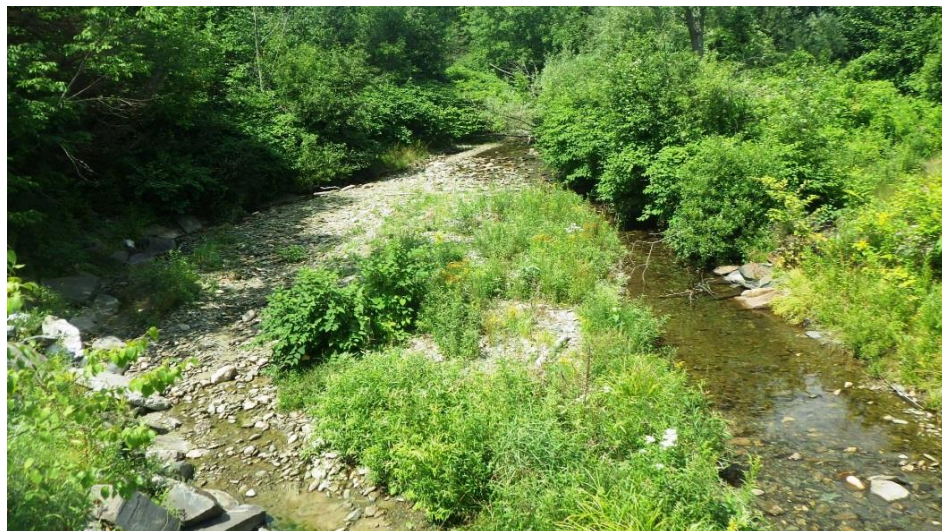
Photo from Latest VTrans Inspection

High-water event redirected the channel.

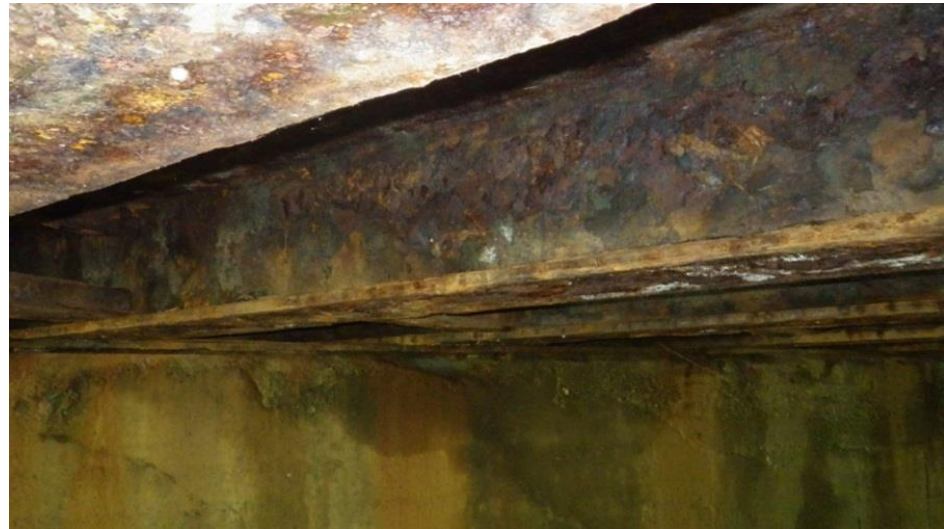
Photo from Latest VTrans Inspection

Beams need to be cleaned and painted due to heavy rusting,

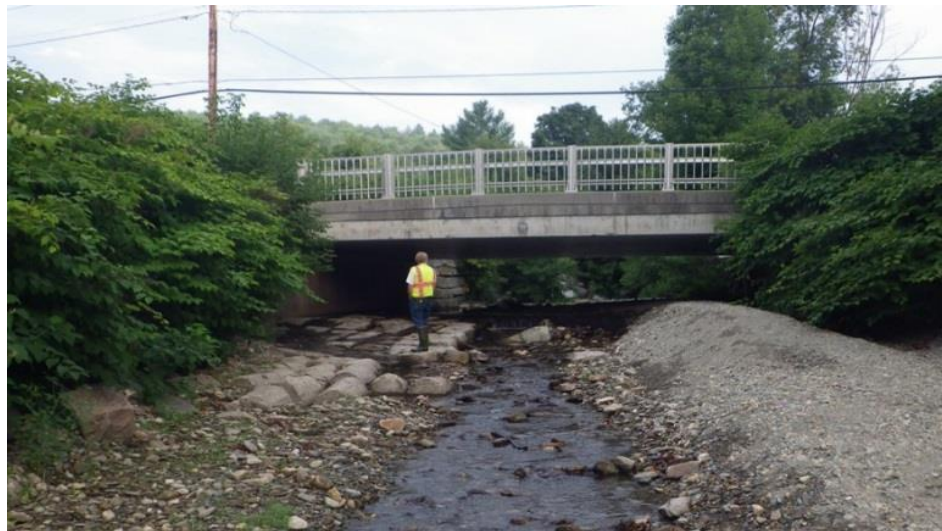
Photo and Finding from 2014 VTrans Inspection

Sediment build-up should be removed,

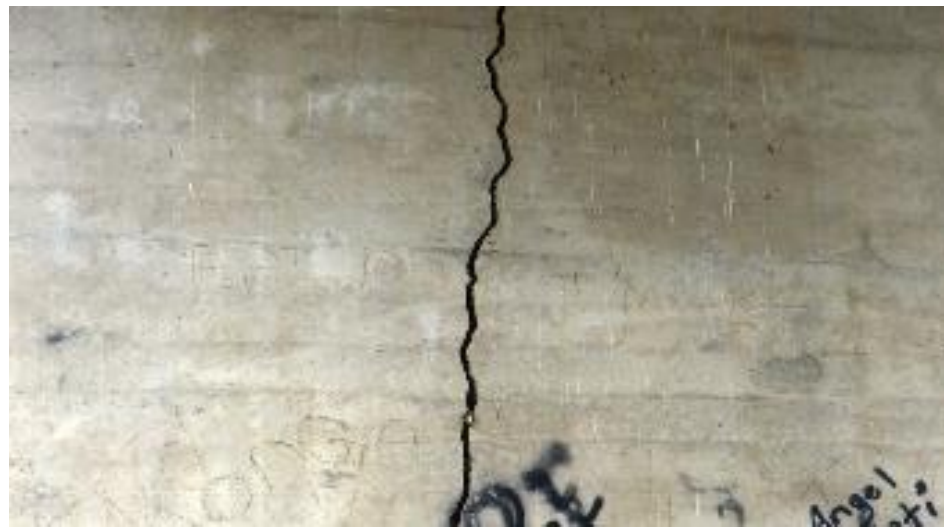
Photo and Finding from 2015 VTrans Inspection

The northern abutment experienced some additional forward movement in 2011.

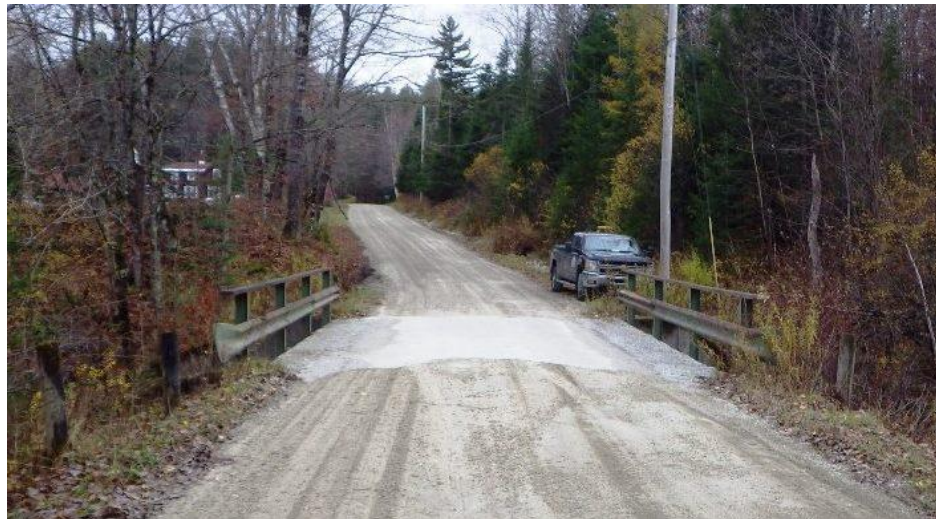
Photo and Finding from 2014 VTrans Inspection

Guard rail system needs upgrading.

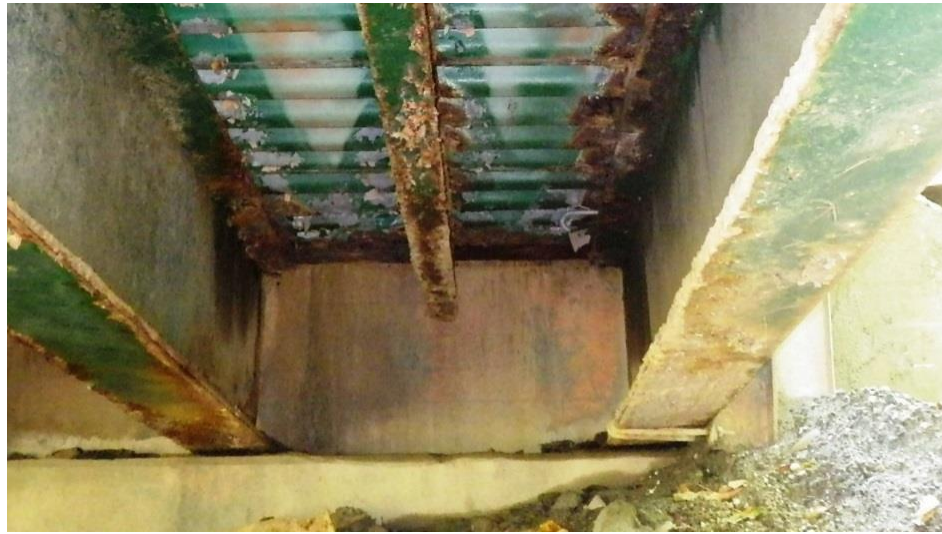
Photo from Latest Inspection

Deck and superstructure will need replacement in the very near future.
